Limited Visual Dam Safety Inspections

OA00037

Reservoir 510

May 2006

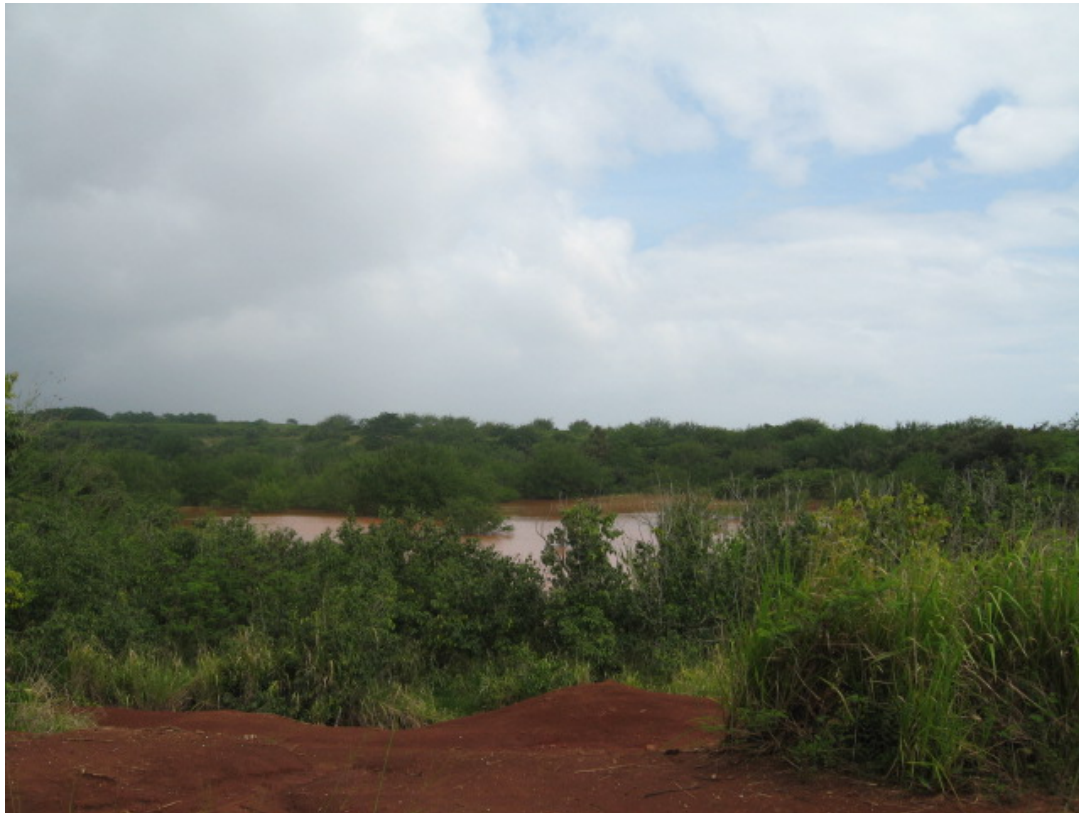
Photo 1 Overview of reservoir.

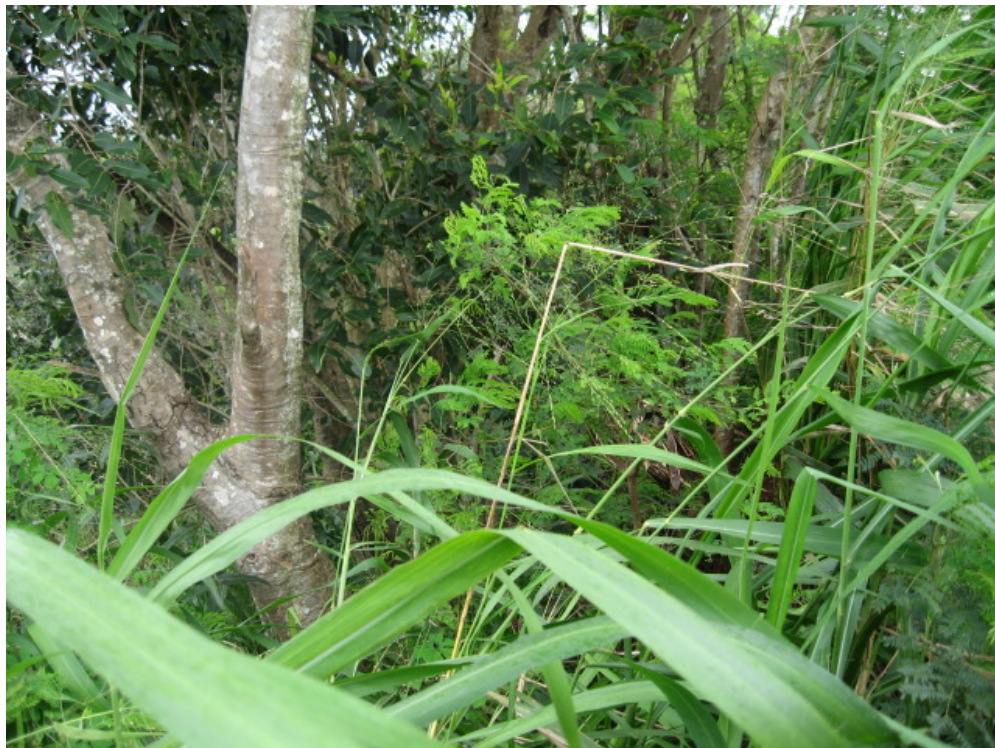
- a. The upstream slope was not inspected.
- b. The upstream slope appeared to be in fair to poor condition and requires corrective action.
- c. Slope protection needs maintenance or repair. Description: Remove trees
- d. The upstream slope was not visible due to high grass and bush vegetation. Clear high vegetation and maintain low to enable easy visual inspection.

- e. Tree(s) were observed on the dam embankment. Trees have been identified as the probably cause of piping failures, and can possibly cause severe damage to the embankment if they are uprooted during a high winds. Corrective action is required to remove the tree hazards from the dam. Acceptable remedies include removal of the tree and its root structure down to a 2" diameter and reconstructing the damaged embankment section. All repair work shall be accomplished as per the requirements of licensed geotechnical or structural engineer. Routinely monitor the damaged area for signs of settlement and seepage.

Photo 2 Upstream slope, heavy vegetation.

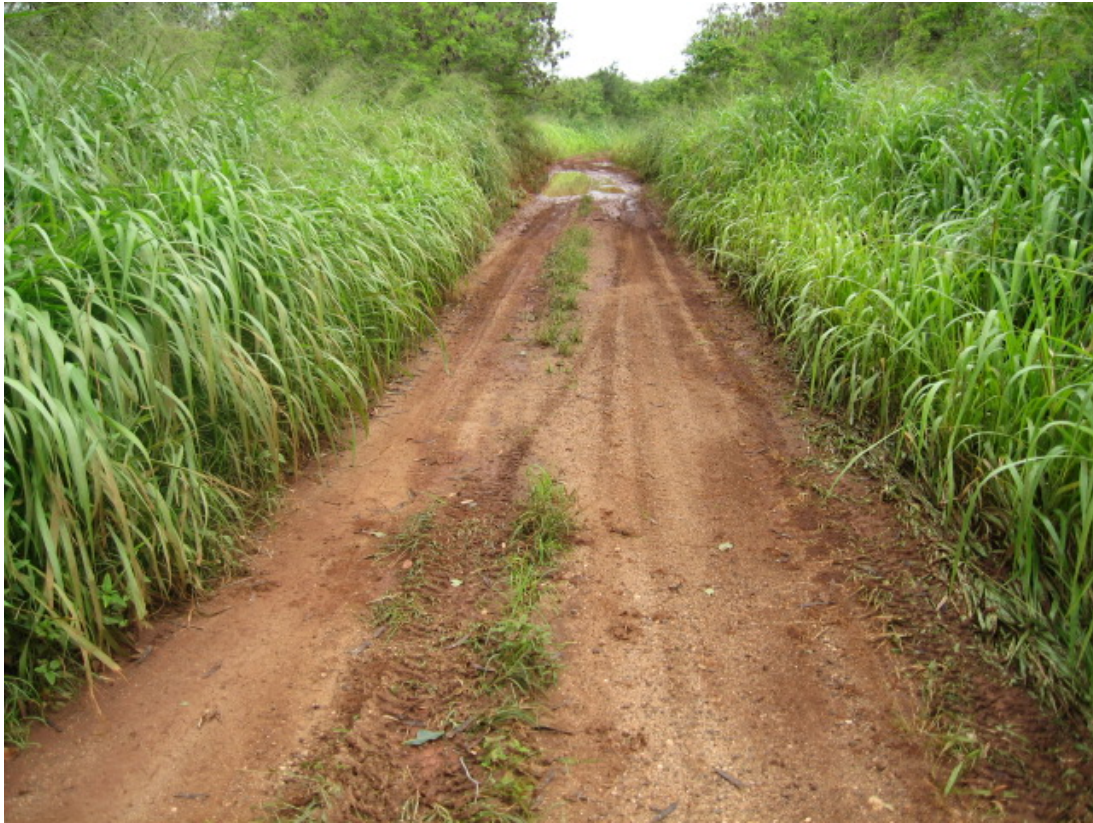
Vegetation was observed on the edges of the crest, notably a large number of trees, with other small woody vegetation and high grass.

- a. The dam crest appeared to be in fair to poor condition and requires corrective action.
- b. Access along the crest was satisfactory.
- c. Portions of the crest were not visible due to high grass and bush vegetation. Clear high vegetation and maintain low to enable easy visual inspection.

- d. Tree(s) were observed along the dam crest. Trees have been identified as the probably cause of piping failures, and can possibly cause severe damage to the embankment if they are uprooted during a high winds. Corrective action is required to remove the tree hazards from the dam. Acceptable remedies include removal of the tree and its root structure down to a 2" diameter and reconstructing the damaged embankment section. All repair work shall be accomplished as per the requirements of licensed geotechnical or structural engineer. Routinely monitor the damaged area for signs of settlement and seepage.

Photo 3 Dam crest.
